HOME INSPECTION REPORT

1 Kencliff Cres
Scarborough

Prepared by: Bob Papadopoulos P.Eng., RHI *

Inspection Date: May 8 2025

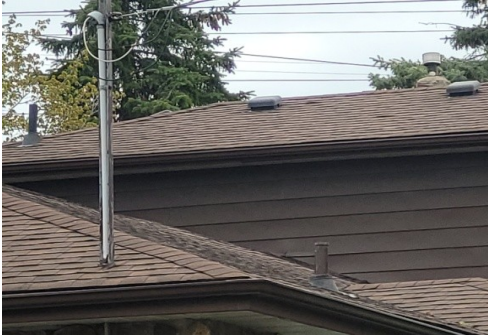
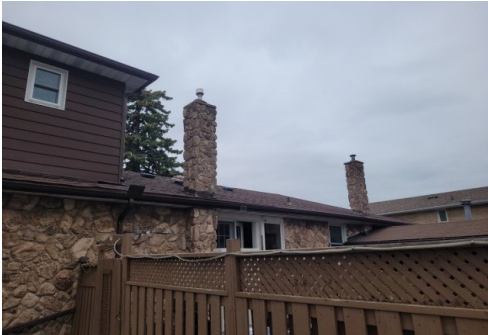
REFERENCE LINK		http://redbrickinspections.ca/docs/2_Roofing_Reference_Guide.pdf			
1 Kencliff Cres		ROOFING/Chimneys			May 8 2025
Description					
Roofing Material:	Location:	Leakage Probability:		Chimney(s) Type:	Location:
Asphalt Shingles:	Slope:	Low	upper	Stone:	East
Asphalt Shingles:	2nd Slope:	Low	lower	Stone:	
Limitations					
Roof Inspected By:	Access Limited By:		Chimney Access Limited By:		
From Grade	Height Tree		Height		
Observations/Recommendations					
<p>Sloped Surface: overall surface in good repair</p> <div style="display: flex; justify-content: space-around;">

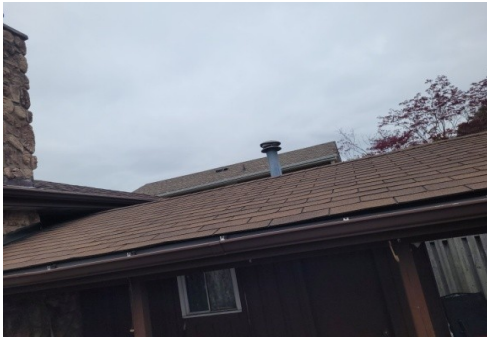
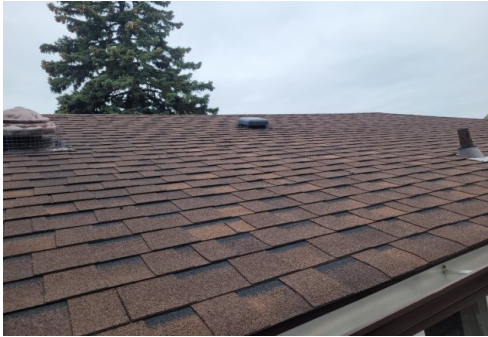
</div> <p>2nd Slope: overall surface in good repair</p> <div style="display: flex; justify-content: space-around;">

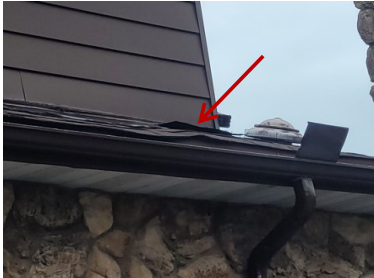
</div> <p>Flashings: loose in some areas along walls - repair</p> <div style="display: flex; justify-content: flex-end;">

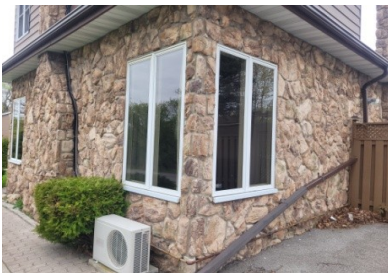
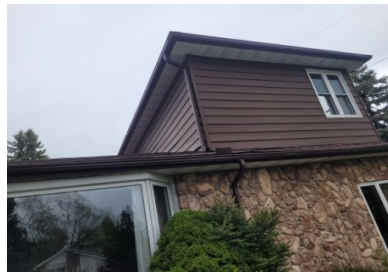
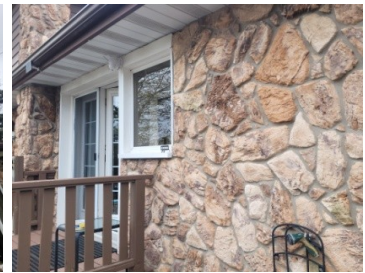
WALL SURFACES: overall in good repair
 Brick: overall in good repair
 Metal Siding: overall in good repair

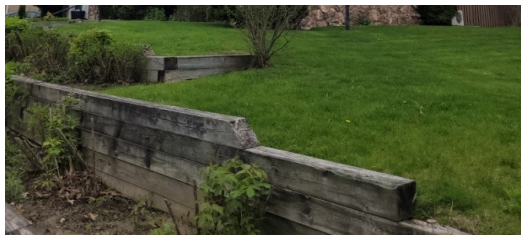
- RETAINING WALL(s): older, repair as required,
 may become more cost effective to replace - budget
 Step(s): south: loose - unsafe - repair
 **Window Well: might be required at basement side window

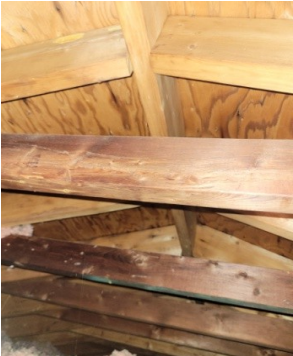
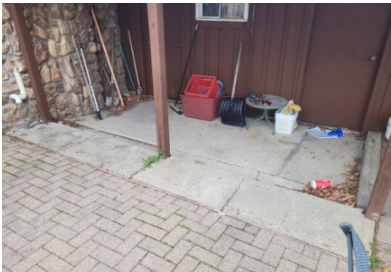
</div> <p>ROOF: upper: in good repair</p> <p>Wood Post: exterior overhang- monitor- budget to replace and install proper footing</p> <div style="display: flex; justify-content: space-around;">

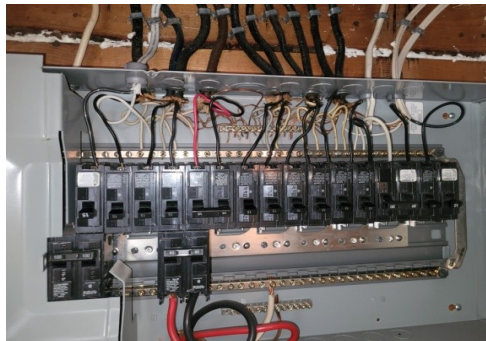
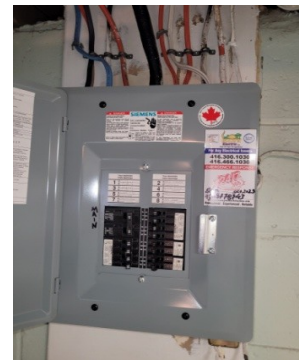
Limitations**Main Disconnect Cover Not Removed****Observations/Recommendations**SERVICE ENTRANCE: **overall in good repair**SERVICE PANEL: **overall in good repair**Auxiliary Panel: **overall in good repair**

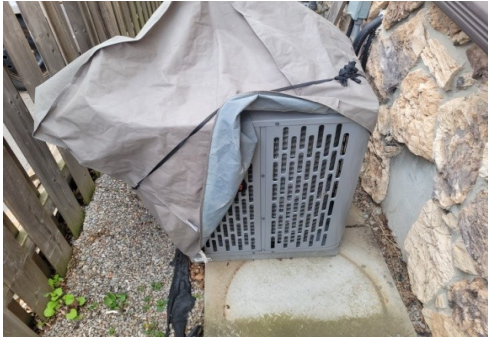
REFERENCE LINK		http://redbrickinspections.ca/docs/7_AC_Heat_Pump_Reference_Guide.pdf	
1 Kencliff Cres		COOLING/Heat Pumps	May 8 2025
Description			
Description:	Cooling Capacity:	Approx. Age:	Typical Life Expectancy:
Air Conditioner (air-cooled):	24 x1,000 BTU/hr	2 yrs. old	10 to 15 yrs.
Ductless (air-cooled)	9 x1,000 BTU/hr	15+	
Limitations			Cooling Performance
Outdoor Coil Covered			Supply Temp F:
			Return Temp F:
Observations/Recommendations			
<p>AIR CONDITIONER: not tested: should be serviced before using service annually</p>

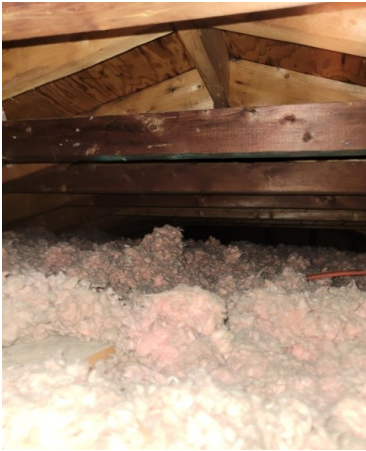
REFERENCE LINK		http://redbrickinspections.ca/docs/8_Insulation_Ventilation_Reference_Guide.pdf		
1 Kencliff Cres		INSULATION/VENTILATION		May 8 2025
Description				
Material:	Location	R-Value	Air/Vapour Barrier:	Venting: Roof
Limitations				
Access Not Gained To Wall Space		Roof Space Inspected from Access Hatch		upper
Access Not Gained To Roof Space				
Observations/Recommendations				
<p>ROOF SPACE: upper, insulation and ventilation is adequate uneven distribution of insulation - improve/add insulation</p>
