# HOME INSPECTION REPORT

1008 Franconia Dr  
Mississauga

Prepared by: Bob Papadopoulos P.Eng., RHI \*

Inspection Date: March 31 2017

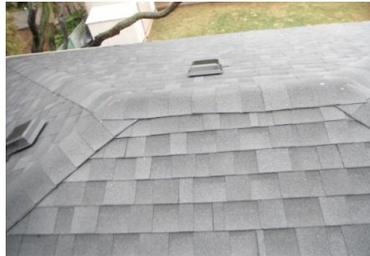
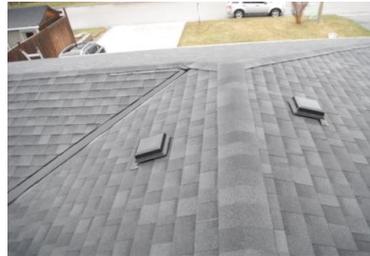
Sloped Surface: newer surface in good repair

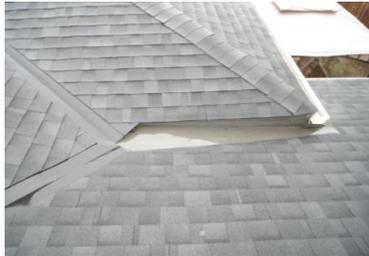
Vulnerable Areas: central area though flashing detail appears to be adequate- monitor

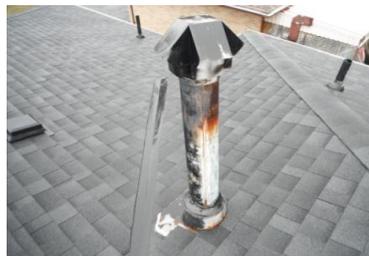
Metal: not in use can be removed and capped

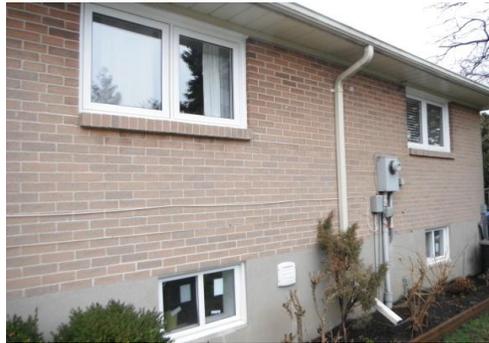
WALL SURFACES: overall in good repair

DOORS/WINDOWS: overall in good repair

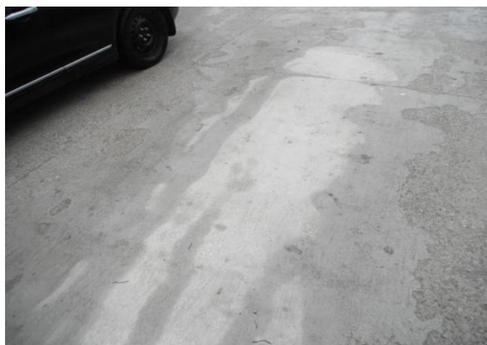
\*\*Driveway(s): pitted surface - overall cosmetic, repair if required

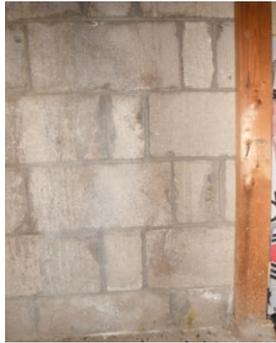
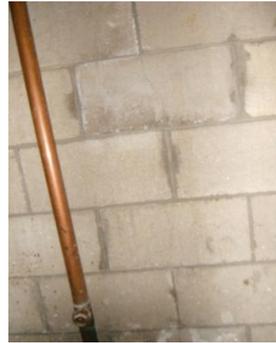
FOUNDATIONS: typical settlement cracks

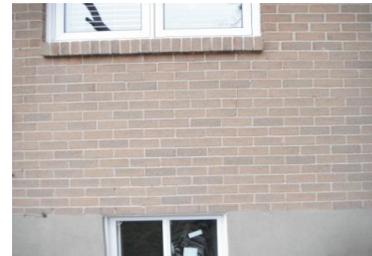
WALLS:  
Brick Veneer: minor crack at rear above window  
overall not critical

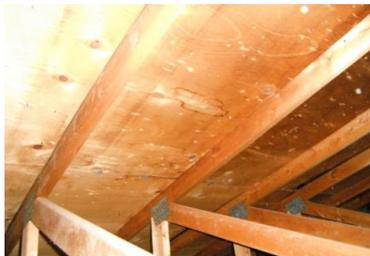
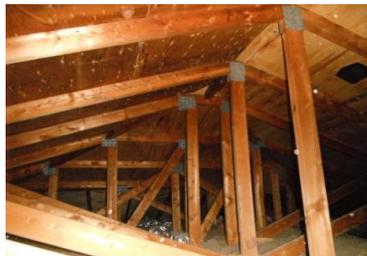
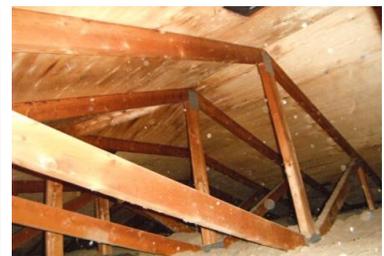
ROOF: overall in good repair, appears that sheathing has been replaced

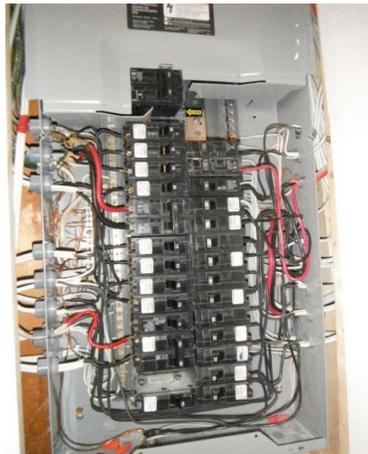
SERVICE PANEL: **crowded/double-taps though overall in good repair**

Note 1: All recommendations are safety issues - Treat them as high priority.

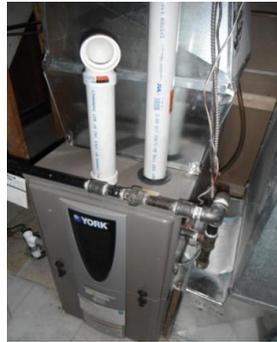
FORCED AIR FURNACE: [service annually](#)

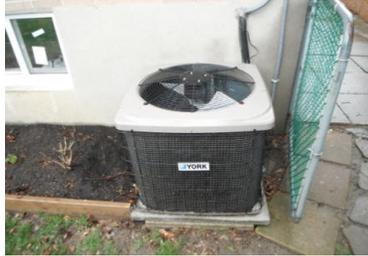
AIR CONDITIONER: not tested: should be serviced before using

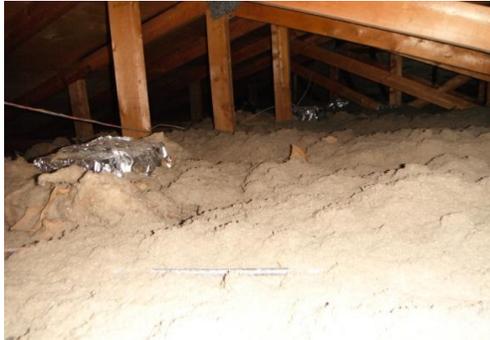
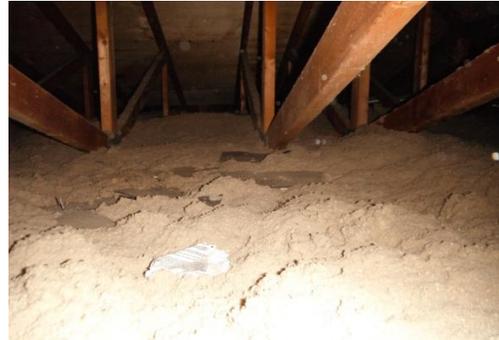
Main Slope Roof: [upgrading insulation will improve comfort and efficiency](#)

2nd Slope Roof: [upgrading insulation will improve comfort and efficiency](#)

Roof Access Hatch: [insulate and weather-strip access hatch to roof space](#)

Ventilation: [add soffit vents when insulating](#)

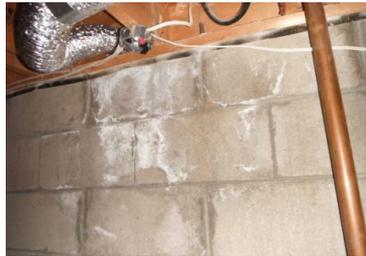
\*\*Basement Leakage: typical efflorescence, staining and dampness for older foundation see steps below

- \*\* Steps recommended in order to minimize basement leakage
1. gutters, downspouts, grading, driveways: ongoing maintenance and repair/see Exterior
  2. cracks/form ties on foundation: monitor/repair as required
  3. excavation/damp-proofing: monitor basement, consider step 3 as a last resort
