# HOME INSPECTION REPORT

107 Perry Cres  
Toronto

Inspection Date: March 28 2018

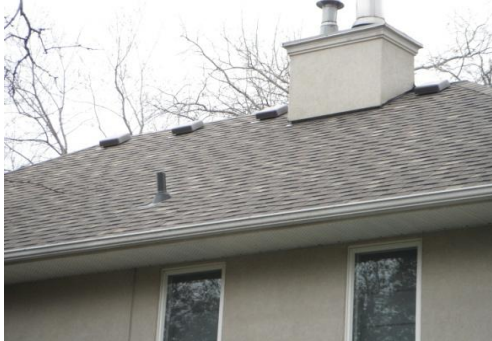
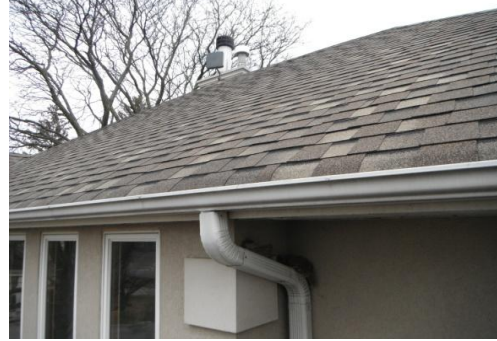
Sloped Surface: [newer surface in good repair](#)

Chimney(s): [in good repair](#)

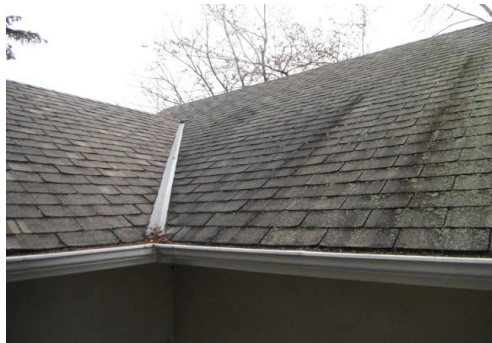
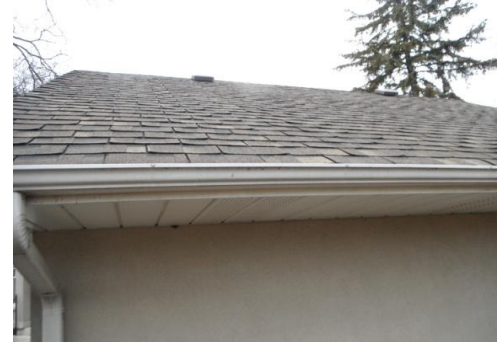
2nd Slope: [lower roof areas including garage, aging shingles, budget to replace within 5-yrs](#)

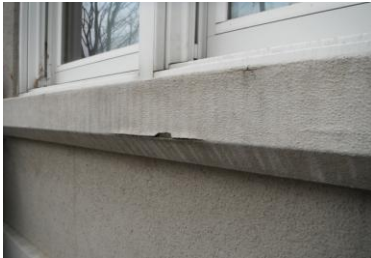
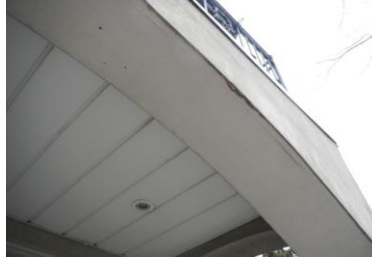
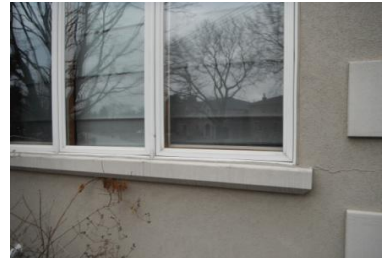
**\*\*Gutters/Downspouts:** requires general maintenance, extend 6-ft away from house

WALL SURFACES: overall in good repair, minor cracks/damage in some areas - repair as required

DOORS/WINDOWS: overall in good repair

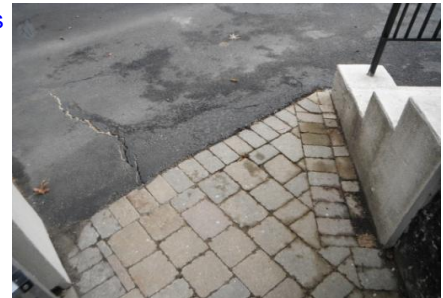
**\*\*Walk(s):** uneven surfaces, budget for repairs

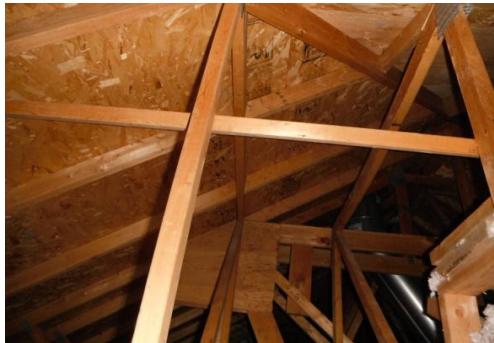
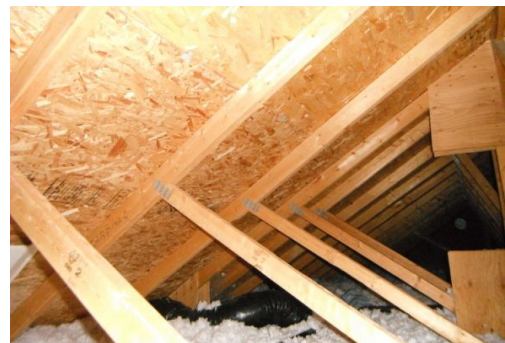
overall well built house, original house structure that has been significantly extended

ROOF: overall in good repair

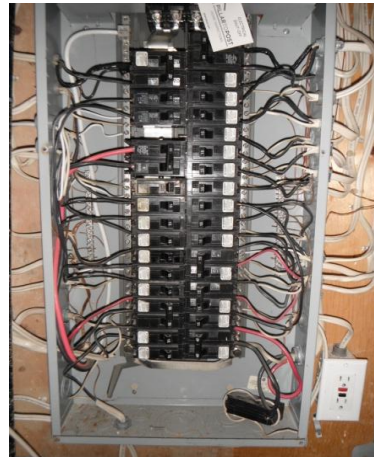
SERVICE PANEL: **overall in good repair**

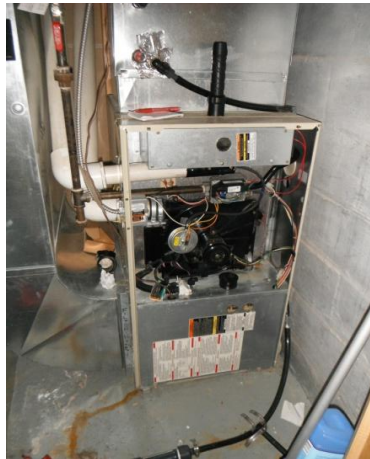
FORCED AIR FURNACE: service annually  
continue servicing until replacement becomes necessary

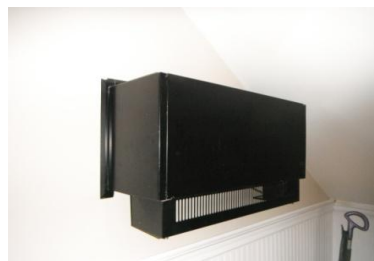
ELECTRIC HEATERS(s): upper room in garage: older unit, functional presently

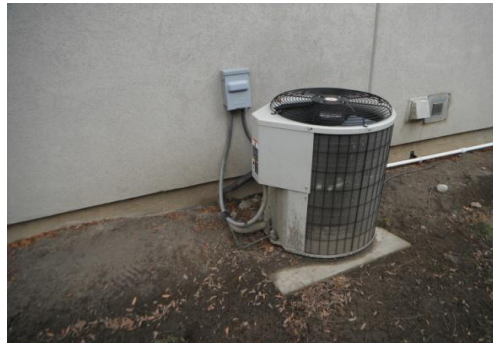
AIR CONDITIONER: not tested: should be serviced before using  
aging unit, continue servicing until replacement becomes necessary  
Outdoor Coil: cabinet not level - repair

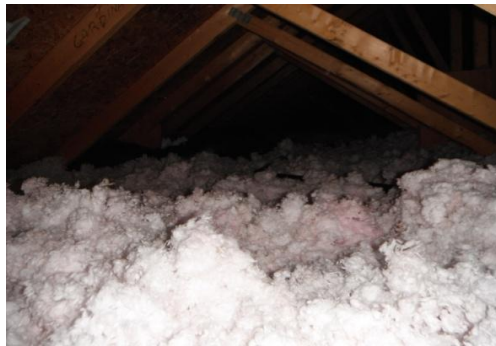
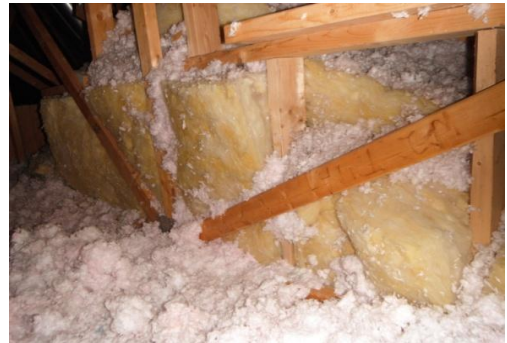
Roof Access Hatch: insulate and weather-strip access hatch to roof space

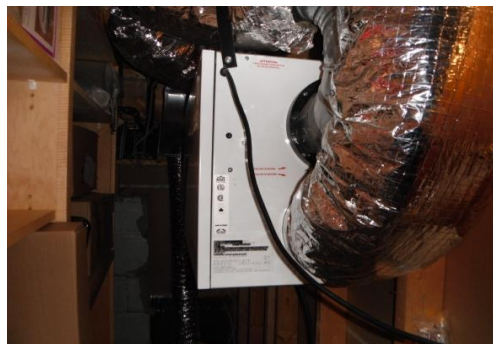
Heat Recover Ventilator: service annually

somewhat restricted access for servicing

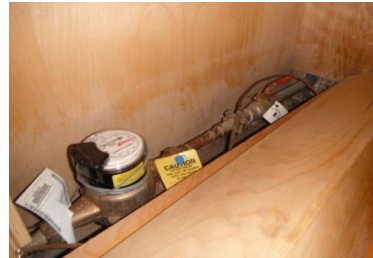
WATERMAIN: some what restricted access - should have quick access to main shut off valve if required

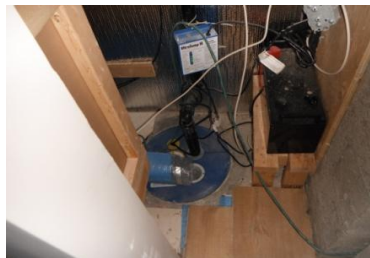
**\*\*Basement Leakage: the basement has been damp-proofed which will minimize moisture and includes a sump pump with a back up battery**
