HOME INSPECTION REPORT

116 Peterborough Ave
Toronto

Prepared by: Bob Papadopoulos P.Eng., RHI *

Inspection Date: Jan 10 2017

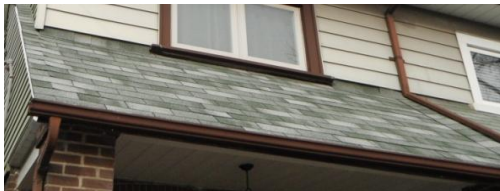
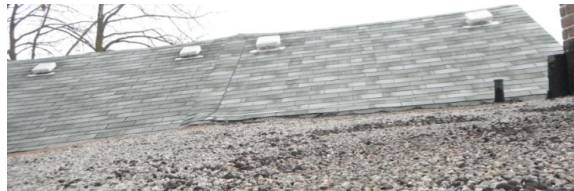
Main Slope: overall surface in good repair

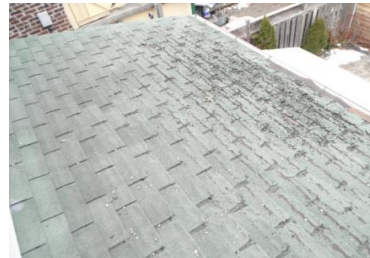
North Slope: old, repalce within 1-yr

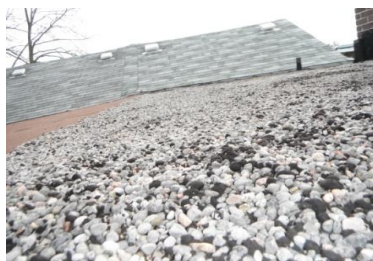
Flat Surface: old, continue servicing until repalcment becomes necessary

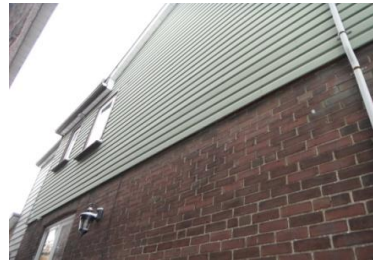
WALL SURFACES: overall well maintained

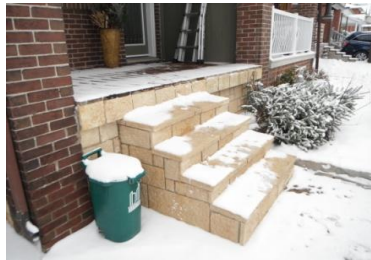
PORCH restored finishes, requires safety/hand rails

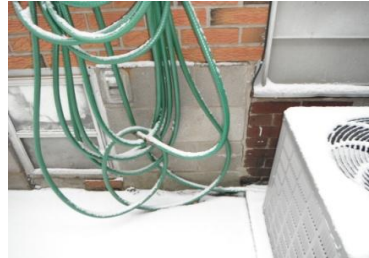
FOUNDATIONS: typical settlement crack at rear extension, repair and monitor

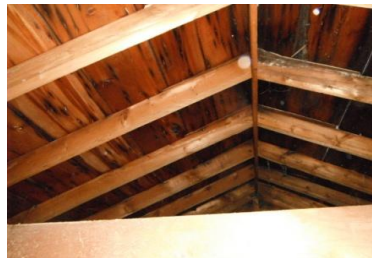
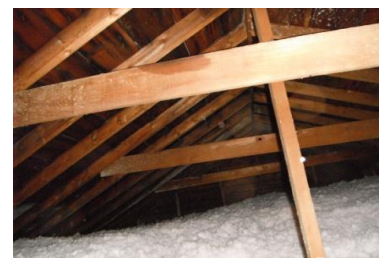
ROOF: overall in good repair, staining due to moisture though no signs of damage - see Ventilation

Party Walls: none in roof space between attached neighbour - recommend installing

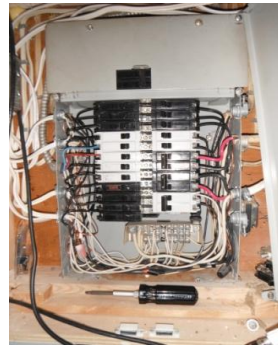
SERVICE PANEL: overall in good repair

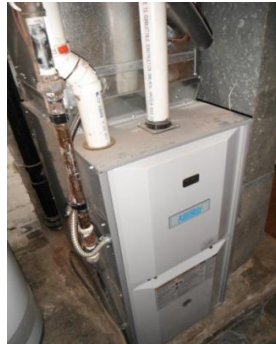
FORCED AIR FURNACE: [service annually](#)

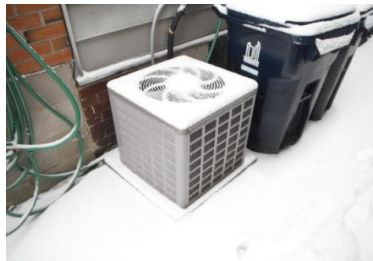
AIR CONDITIONER: not tested: should be serviced before using

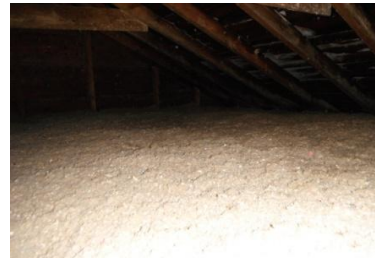
ROOF SPACE: insulation has been upgraded
