HOME INSPECTION REPORT

16 Langemark Ave

Prepared by: Bob Papadopoulos P.Eng., RHI *

Inspection Date: March 16 2020

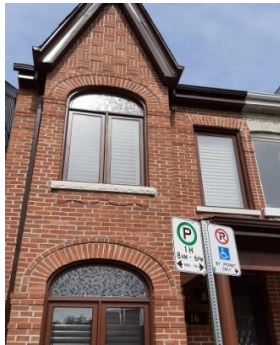
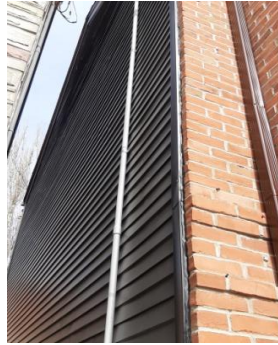
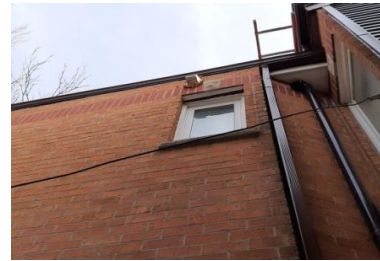
Brick: [overall in good repair](#)

Metal Siding: [overall in good repair](#)

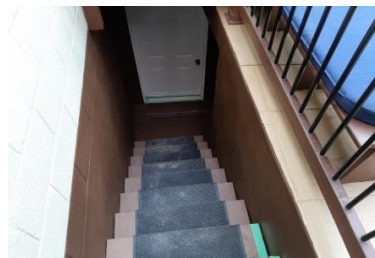
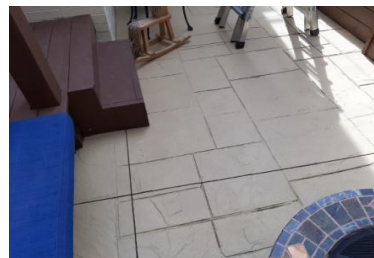
**BASEMENT WALKOUT: [overall in good repair, steps require hand railings](#)

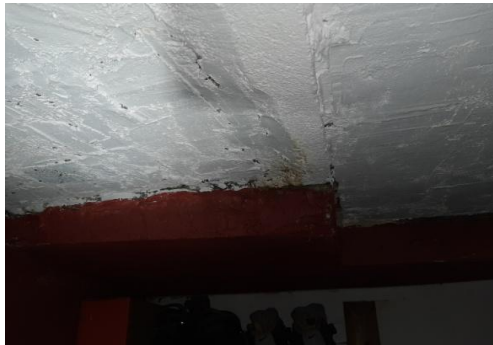
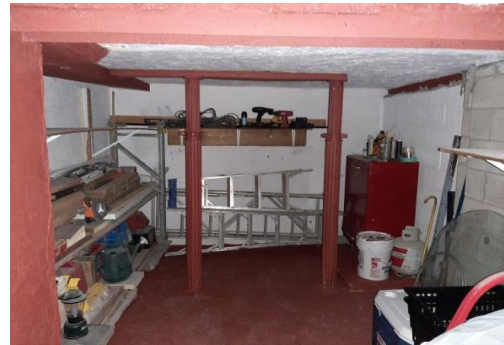
FLOORS:
 Concrete Floors: basement rear extension: reinforced concrete suspended slab,
 overall in good repair, continue to treat patio floor area above with
 water sealant (1-per-3-5-yrs) to protect reinforcing steel bars in concrete

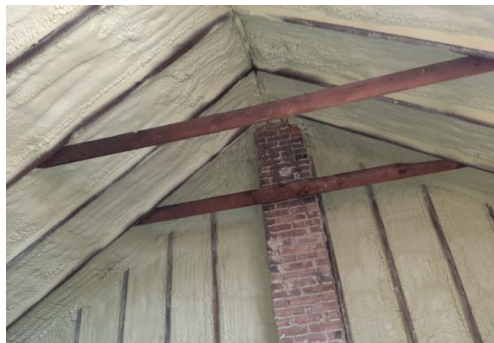
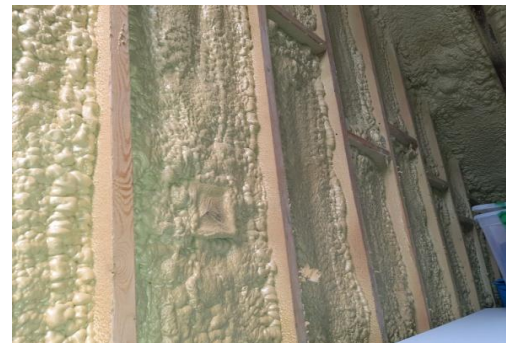
ROOF: main slope rafters in good repair
 Party Walls: east side attached to neighbours should be covered with fire rated drywall

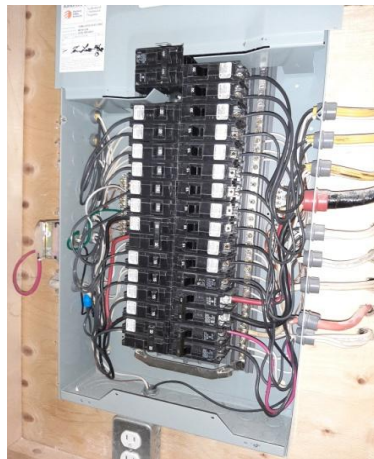
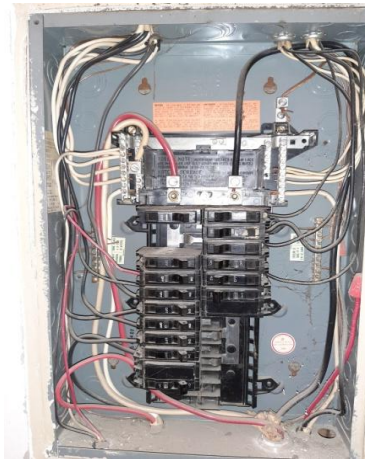
SERVICE PANEL: **overall in good repair**

Auxiliary Panel: **overall in good repair**

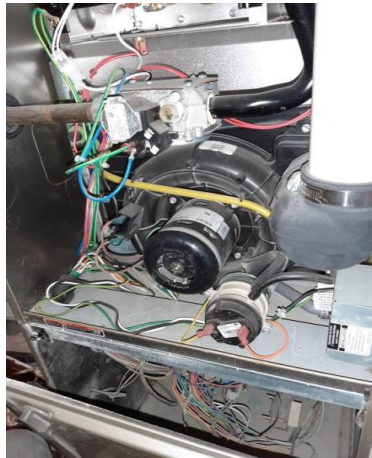
FORCED AIR FURNACE: [service annually](#)

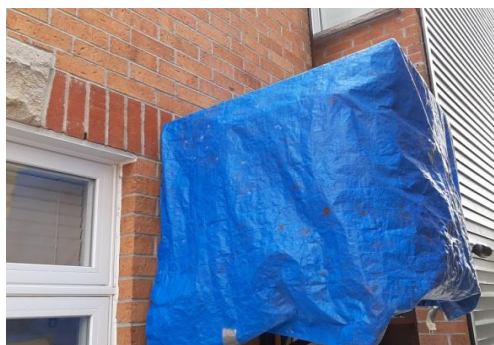
AIR CONDITIONER: not tested: should be serviced before using

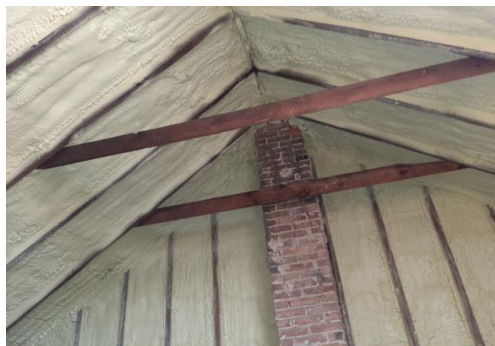
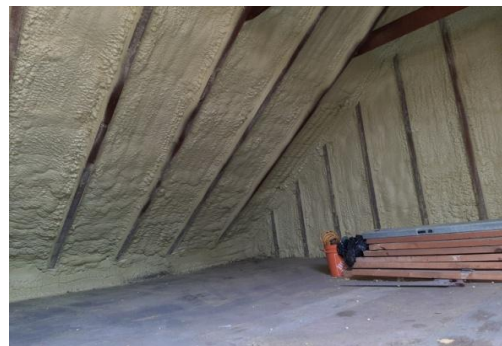
ROOF SPACE: main slope rafters have been insulated with spray foam which is above average

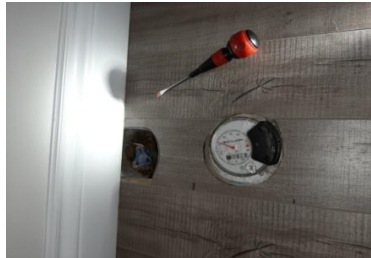
WATERMAIN: meter has been buried in concrete floor - should be above accessible
