# HOME INSPECTION REPORT

161 Glendale Ave  
Toronto

Prepared by: Bob Papadopoulos P.Eng., RHI \*

Inspection Date: April 1 2016

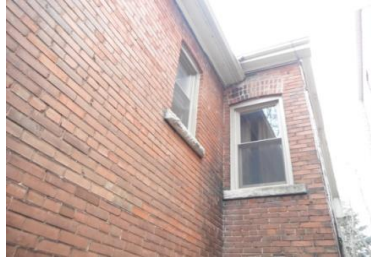
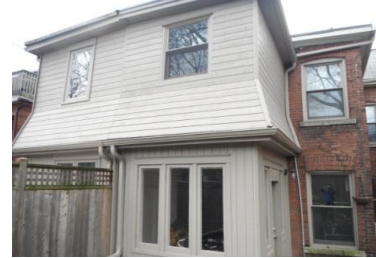
WALL SURFACES: overall well maintained

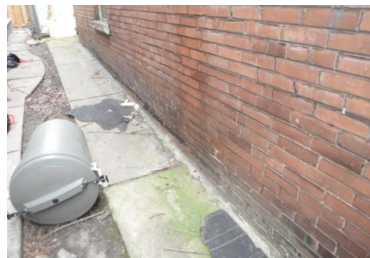
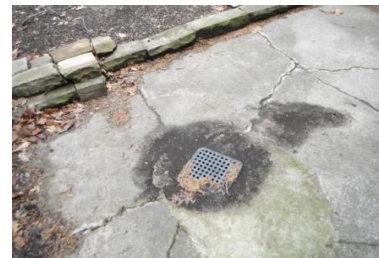
\*\*Walk(s): cracked concrete surfaces, step repairs, budget to replace  
 seal gaps at wall around perimeter to minimize moisture in basement,  
 new drain at rear though portion of pipe is older as observed  
 form the basement floor drain at rear window- drain may require repair

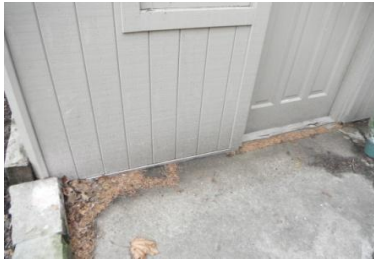
Description				
Configuration:	Foundations:	Floor :	Walls :	Roof/Ceiling Framing:
Basement:	Stone	Wood Joists	Masonry (Double-Brick)	Wood Rafters/Joists
Crawl Space:	Not Visible		Wood Frame (Siding)	
Limitations				
Restricted Access to:	Foundation Wall Not Visible: <u>60</u> %			
<a href="#">Wall Space</a> <a href="#">Roof Space</a> <a href="#">Crawl Space</a>				
Observations/Recommendations				
<p>FOUNDATIONS: <a href="#">basement: spalling damaged parging - repair as required or if renovating basement, overall not critical as long as mortar is in good repair</a></p> <p>FLOORS/WALLS <a href="#">rear extension: wood sill/joists are below grade and prone to damage, overall this is an older condition, digging around perimeter and repairing and sealing recommended</a></p>

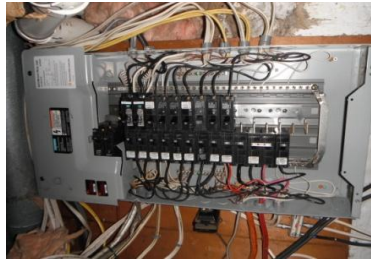
**Observations/Recommendations**SERVICE PANEL: **upgraded panel in good repair**

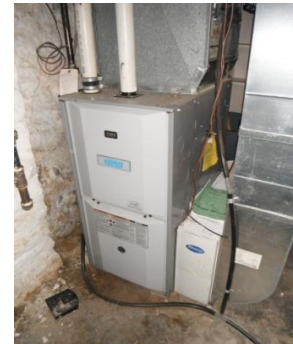
Induced Draft Fan: noisy - may require replacement in short term

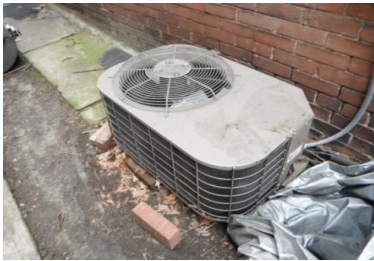
Description			
Description:	Cooling Capacity:	Approx. Age:	Typical Life Expectancy:
Air Conditioner (air-cooled):	18 x1,000 BTU/hr	10 yrs. old	15 yrs.
Limitations			Cooling Performance
Cannot Test With Low Outdoor Temp			Supply Temp F:
			Return Temp F:
Ref#*	Observations/Recommendations		
	<p>AIR CONDITIONER: not tested: should be serviced before using capacity possibly lower for size of house, may require additional cooling unit for 3rd level, monitor performance</p>

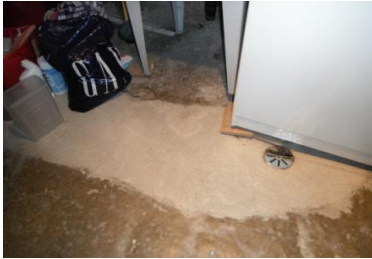
Description		
Service Piping into House:	Main Shut Off Valve at:	Water Flow (Pressure):
Copper	Basement-Front	Adequate
Supply Piping & Pump(s):	Waste Piping & Pump(s):	Water Heater
Copper	Plastic	Type: Tankless
Plastic	Cast Iron	Fuel Type: Gas
		Capacity: N/A
		Age Yrs.: 6
		Life Expectancy: 15
Limitations		
Isolating/Relief Valves & Main Shut Off Valves Not Tested	Concealed Plumbing not Inspected	
Kitchen and Laundry Appliances Were Not Inspected	Tub/Sink Overflows Not Tested	
Ref#*	Observations/Recommendations	
	<p>SUPPLY PIPING:</p> <p>WATERMAIN: upgraded to copper</p> <p>Piping: plastic supply piping is connected with brass fittings- some brands have been know to leak - should be monitored</p> <p>WASTE PIPING:</p> <p>Basement Floor Drain: upgraded with new main waste drain however no backflow valve observed- recommended especially if renovating basement</p>
