# HOME INSPECTION REPORT

19 Bicknell Ave  
Toronto

Prepared by: Bob Papadopoulos P.Eng., RHI \*

Inspection Date: Sept 7 2016

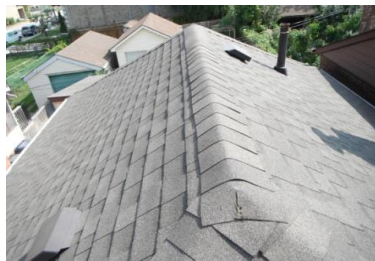
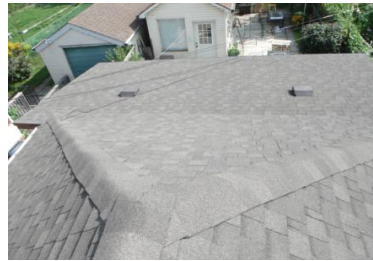
Sloped Surface: **newer surface in good repair**

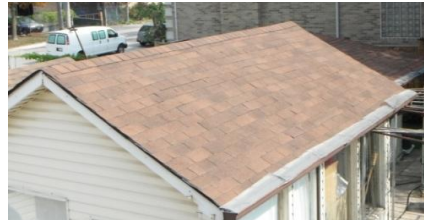
Garage: **overall surface in good repair**

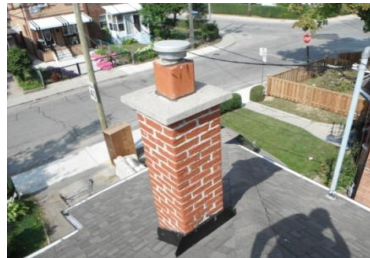
Central: **rebuilt and in good repair**

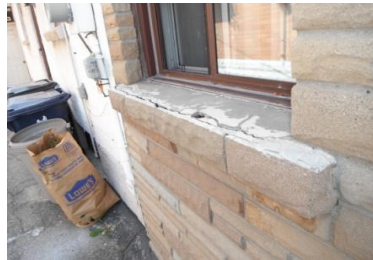
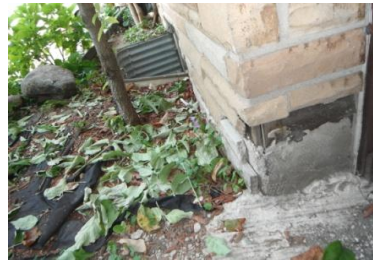
WALL SURFACES: general repairs required in various areas

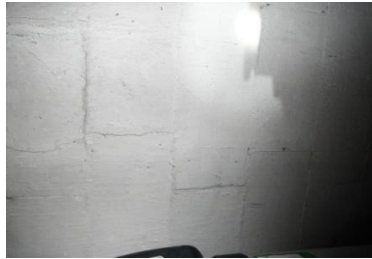
FOUNDATIONS: minor settlement crack observed in furnace room overall not unusual

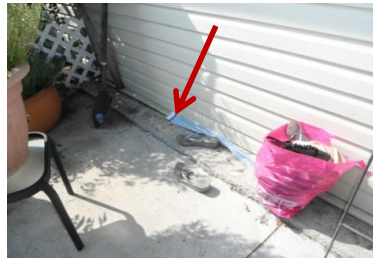
FLOORS: rear extension, framing is close to grade and prone to moisture damage, adding a concrete sill around the perimeter recommended

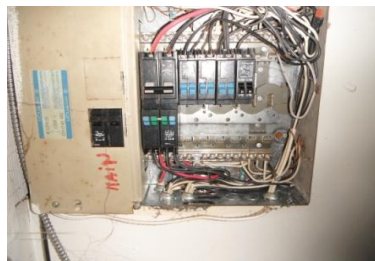
**SERVICE PANEL: too many double tap breakers, add more breakers**

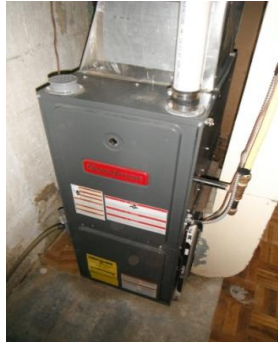
FORCED AIR FURNACE: [service annually](#)
