HOME INSPECTION REPORT

6 Sherin Crt

Toronto

Inspection Date: Apr 1 2021

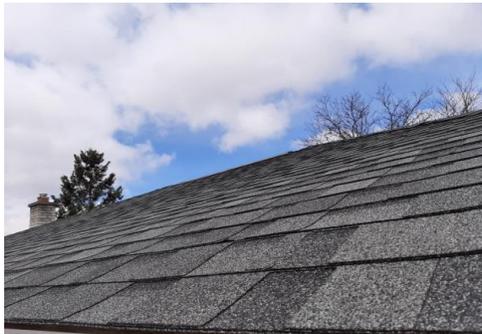
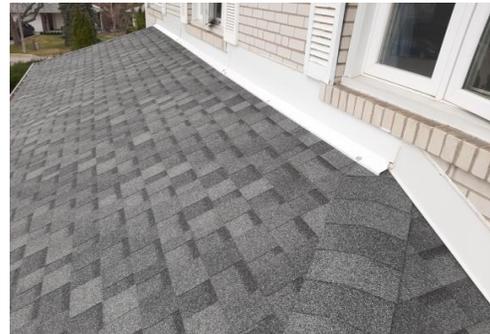
Sloped Surface: [overall surface in good repair](#)

Note: [Recommend Annual Maintenance Contract for Roof Surface, Flashing Details and Chimney\(s\)](#)

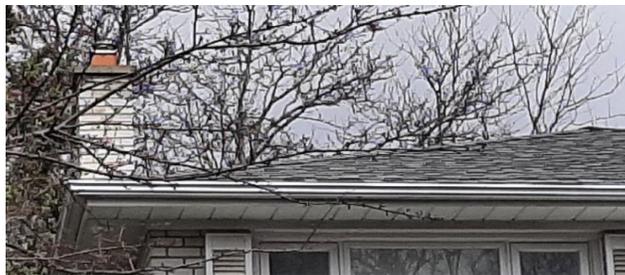
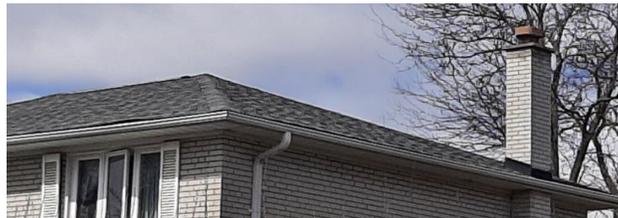
Chimney(s): [overall in good repair](#)

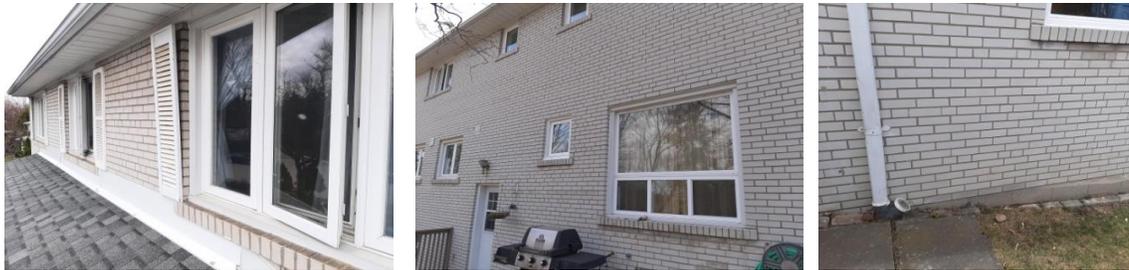
DOORS/WINDOWS: overall in good repair

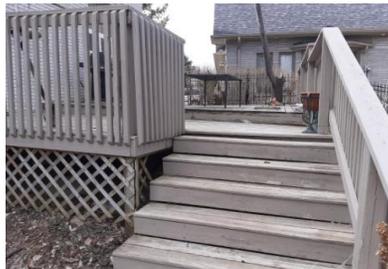
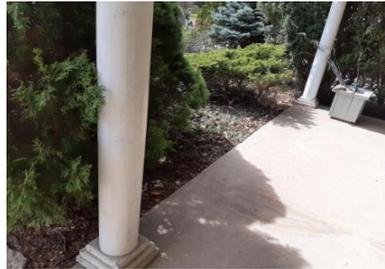
DECK: settlement, sloping floor, overall complete replacement is likely more cost effective

EXTERIOR Overall well maintained. Deck replacement anticipated.

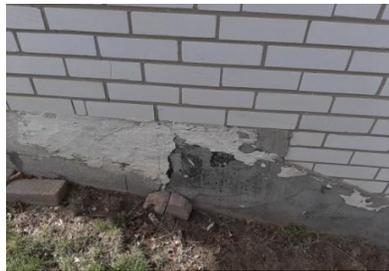
FOUNDATIONS: typical settlement crack on east side - minor

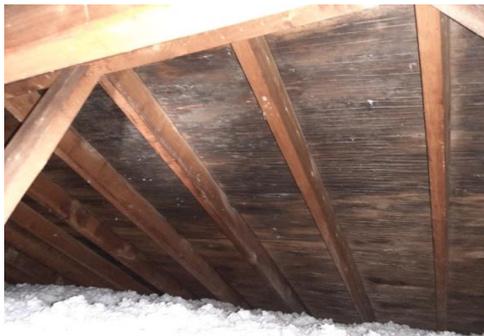
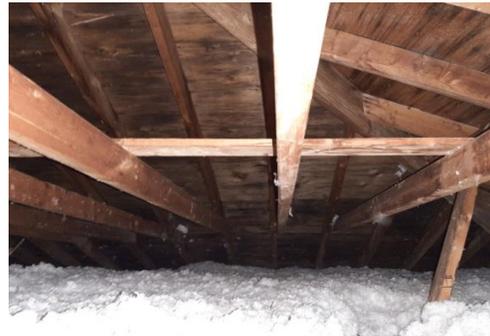
STRUCTURE Overall well built house. Underside of roof sheathing shows signs of mould -see details.

ROOF: underside shows signs of mould though no damage observed
recommend further evaluation by specialist and remediation/mould treatment

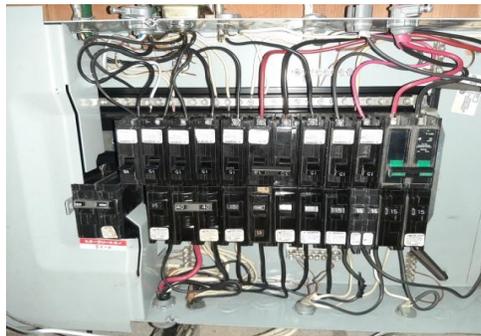
SERVICE PANEL: overall in good repair
likely requires larger panel or sub panel if renovating

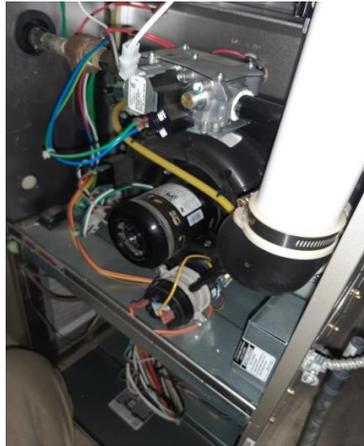
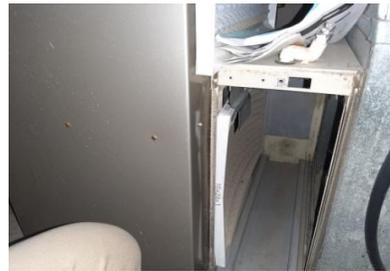
Electronic Filter: [not in use, recommend using larger thickness filter for cabinet](#)

FORCED AIR FURNACE: [service annually](#)

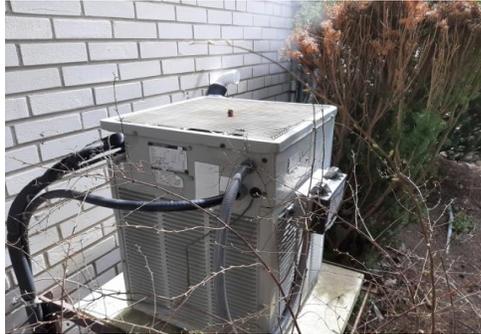
AIR CONDITIONER: not tested: should be serviced before using old unit, continue servicing until replacement becomes necessary recommend replacing with new unit for improved efficiency

COOLING/
HEAT PUMPS The air-conditioner is older. Continue servicing until replacement becomes necessary.

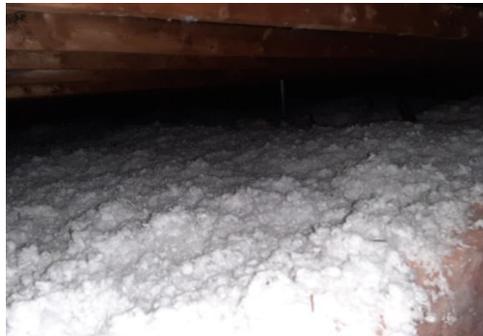
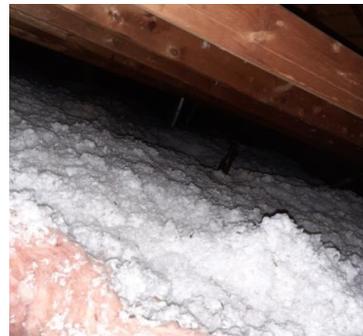
ROOF SPACE: insulation has been upgraded which will improve comfort and efficiency
 Roof Access Hatch: insulate and weather-strip access hatch to roof space
 Ventilation: recommend installing soffit vents

INSULATION/
VENTILATION Roof space insulation has been upgraded. Roof space requires ventilation improvements.
