HOME INSPECTION REPORT

85 Rayne Ave
Oakville

Inspection Date: Sept 28 2023

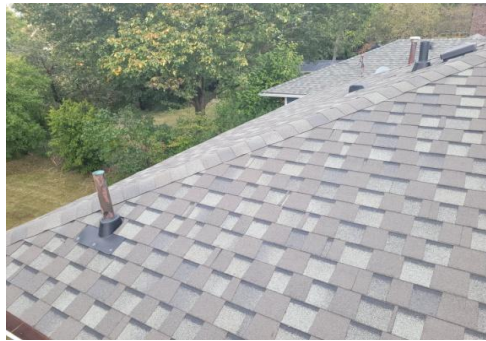
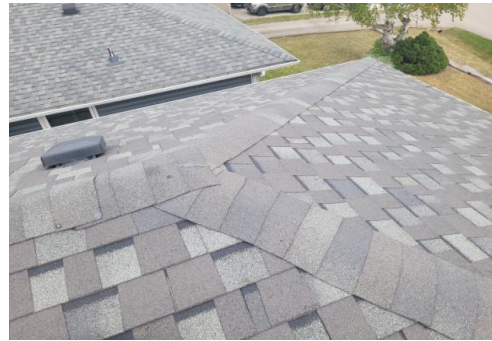
Sloped Surface: [overall surface in good repair](#)

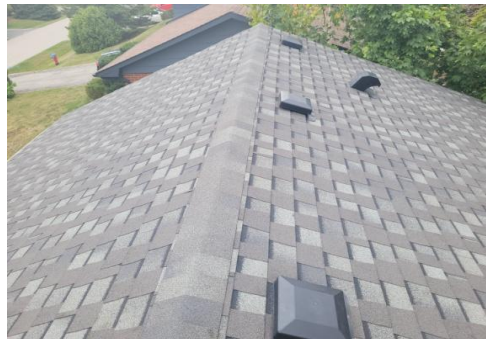
2nd Slope: [overall surface in good repair](#)

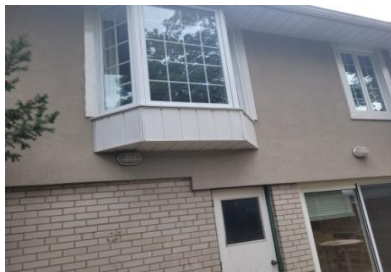
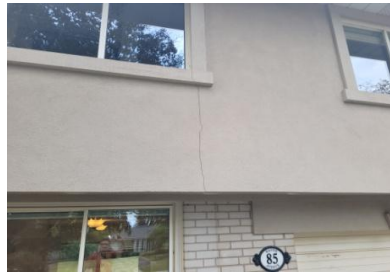
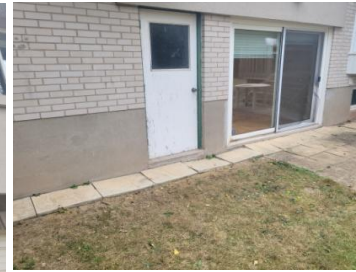
****Gutters/Downspouts:** requires maintenance/cleaning

Soffit & Facia: requires general repairs and maintenance
risk of animals

WALL SURFACES: overall in good repair
DOORS/WINDOWS: overall in good repair
Synthetic Stucco: minor crack - repair

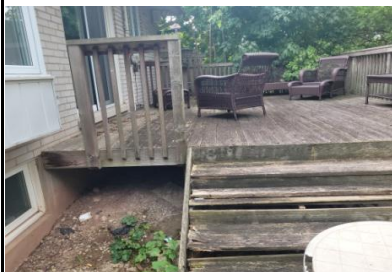
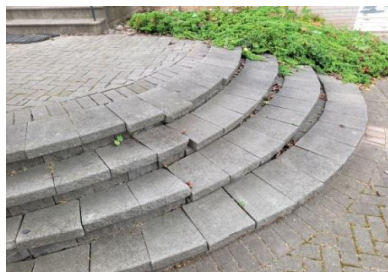
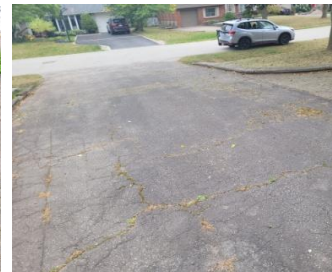
DECK unsafe- requires replacement

****Landscaping:** settlement, steps settlement unsafe, requires repairs

PORCH step structure loose - repair

****Driveway(s):** old, re-surface

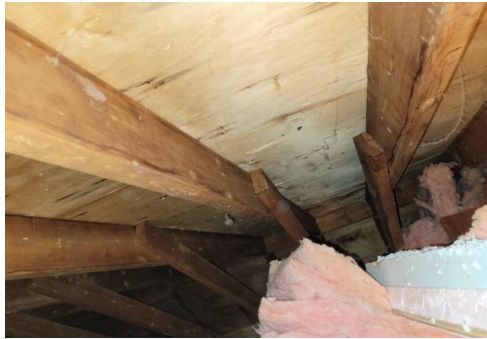
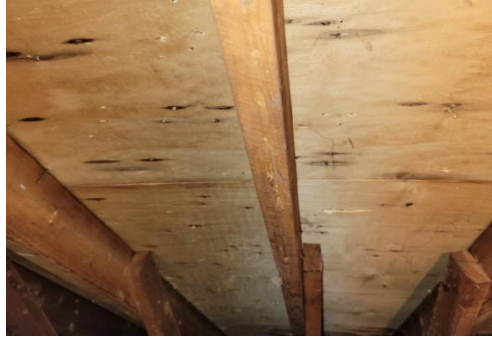
ROOF: lower roof

overall in good repair

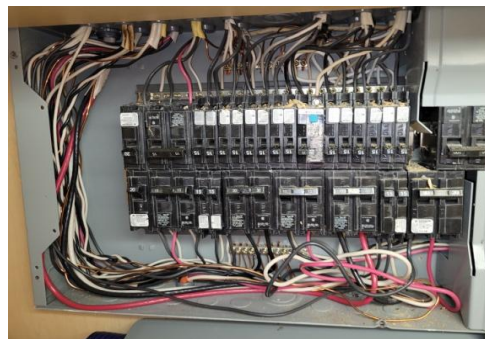
SERVICE PANEL: overall in good repair

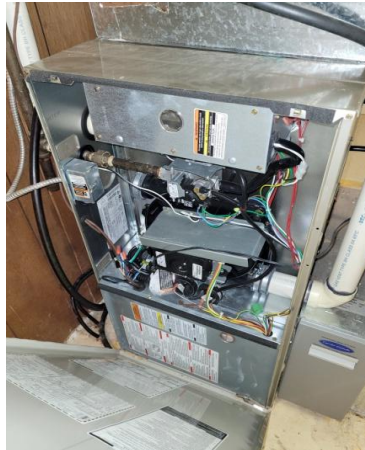
FORCED AIR FURNACE: [not tested: should be serviced before using](#)

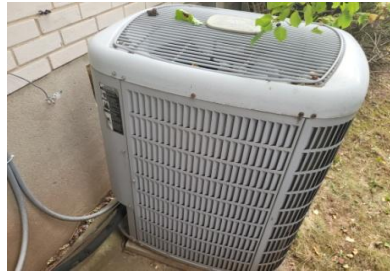
AIR CONDITIONER: [aging unit, continue servicing until replacement becomes necessary](#)
Outdoor Coil: [adjust to be level](#)

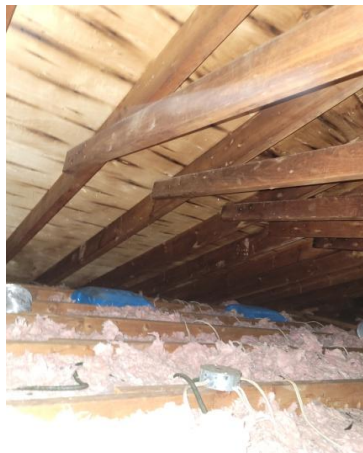
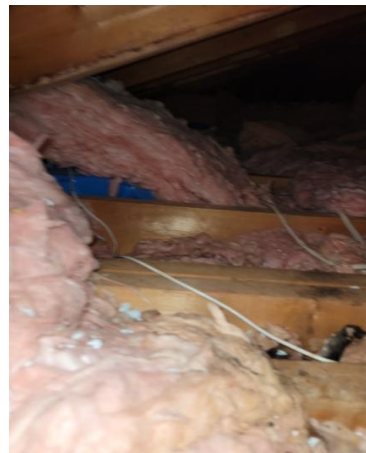
ROOF SPACE: both spaces - prior animal damage/soiled likely requires removal/replacement spaces might require specialist cleaning/treatment recommend further evaluation by specialist
