HOME INSPECTION REPORT

89 - 1280 Bridletowne Circle
Scarborough

Prepared by: Bob Papadopoulos P.Eng., RHI *

Inspection Date: Aug 30 2018

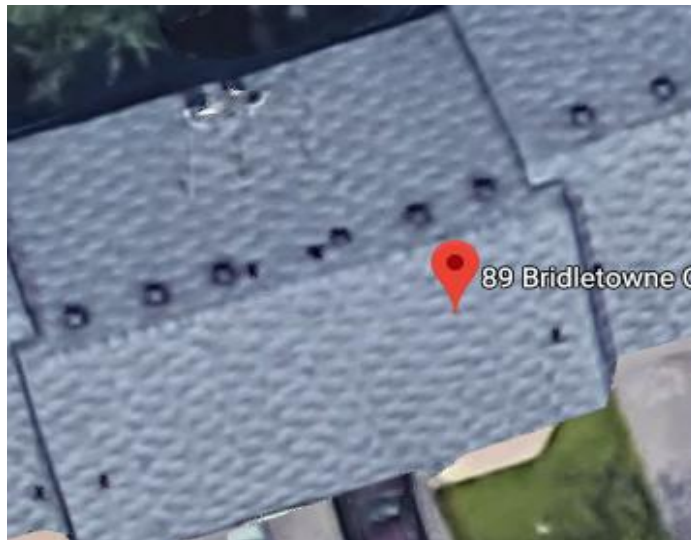
height of roof limited visibility

surface was assessed with Google Map 2015

overall shingles appear to be high quality consistent with north and south upper wall shingles and in good repair

Note: Recommend Annual Maintenance Contract for Roof Surface, Flashing Details and Chimney(s)

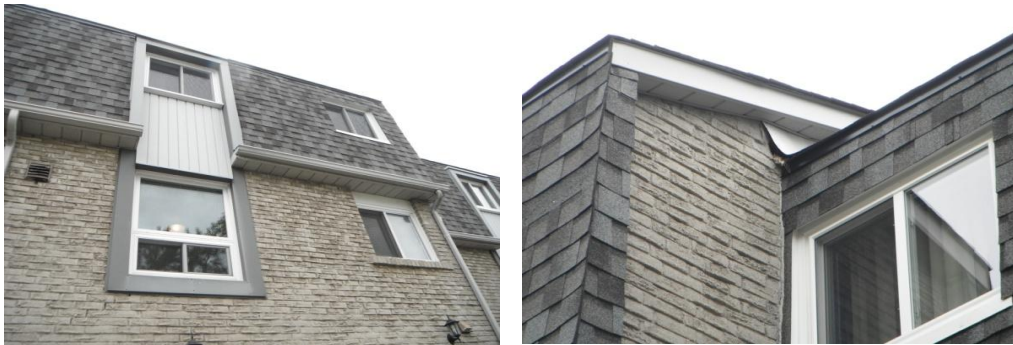
WALL SURFACES: overall in good repair, gap in flashing at southeast - minor repair
DOORS/WINDOWS: overall in good repair

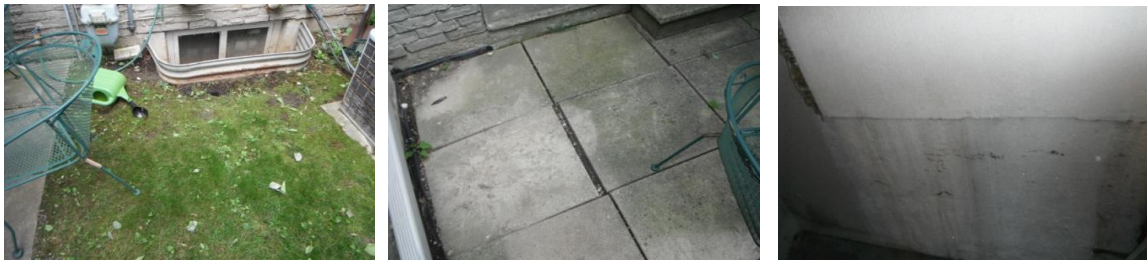
**Lot Grading: rear yard - low areas require re-grading away from house
**Window Well: provide cover, re-grade away from window well, evidence of straining on interior foundation

Note: Maintain Gutters & Downspouts annually. Extend Downspouts at least 6-feet away from the house

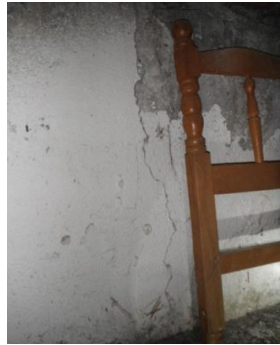
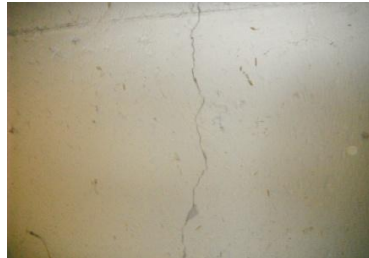
FOUNDATIONS: crawl space: typical settlement cracks

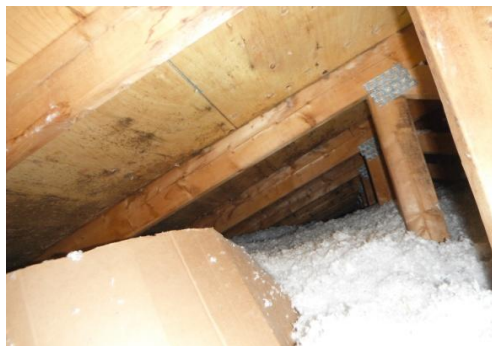
mildew observed on underside of sheathing - overall minor though professional treatment should be considered to avoid mould growth

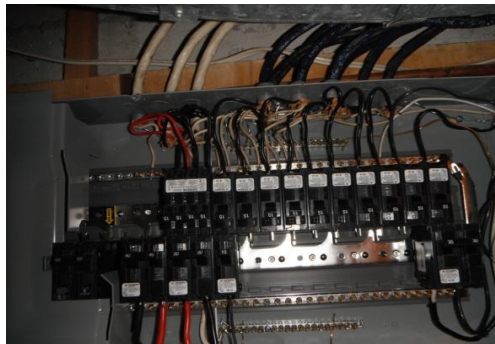
SERVICE PANEL: overall in good repair, aluminum wire connection should be treated with antioxidant -see below

BRANCH WIRING: majority is aluminum as is typical age of neighbourhood, recommend electrician to audit connections in panel and outlets,

typically insurance requires ESA report as well, overall cost approx \$1000 to \$1500

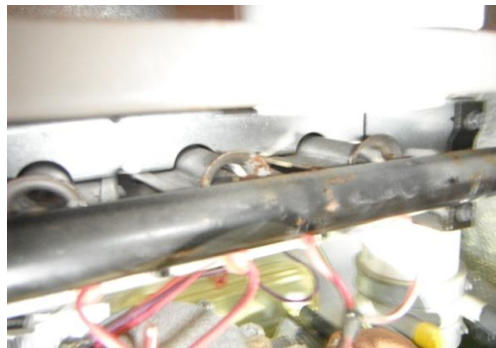
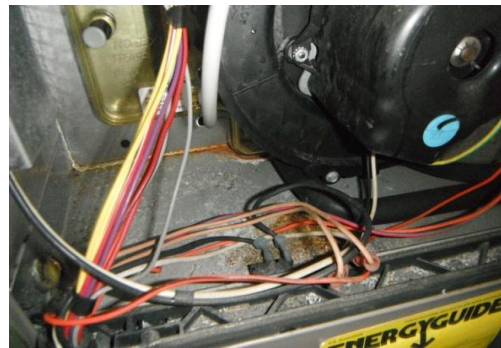
FORCED AIR FURNACE: [service annually](#)
[minor rusting observed in cabinet and burners, budge tot replace components,](#)
[the fan limit switch requires repair or replacement](#)

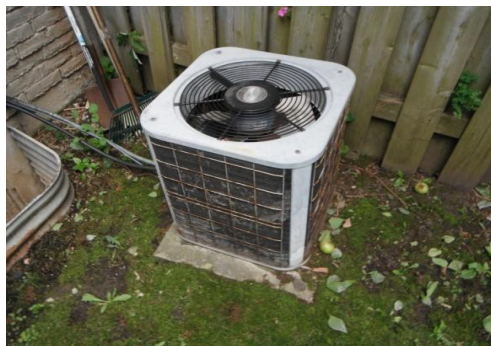
AIR CONDITIONER: old unit, continue servicing until replacement becomes necessary
replacing will reduce energy cost
Outdoor Coil: requires service/cleaning

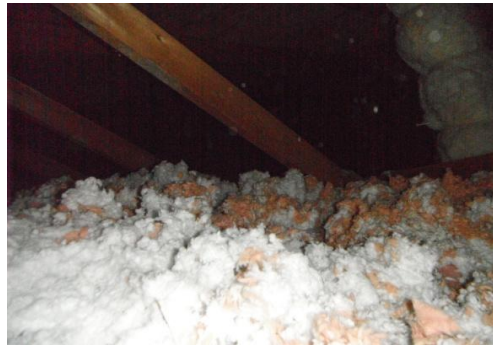
ROOF SPACE: insulation has been upgraded

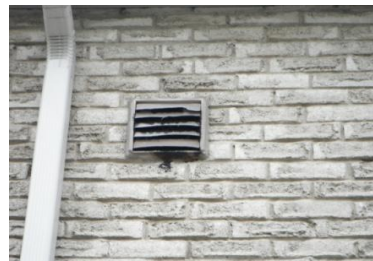
Exhaust Fan Vents: kitchen exhaust on exterior wall appears to be 'greasy', recommend service or replace

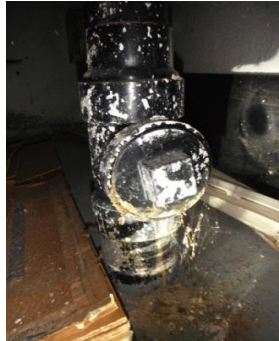
Stack: **crawlspace: access cap - minor leak- minor repair**

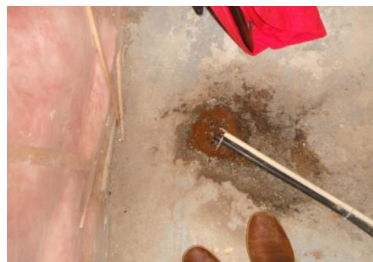
Basement Floor Drain: **corroded strainer - replace**

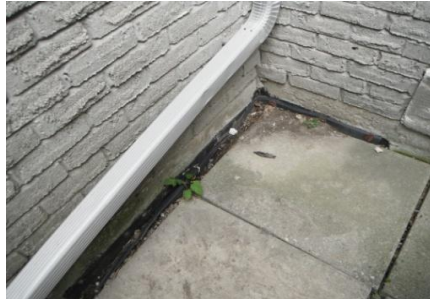
**Basement Leakage: typical efflorescence, staining and dampness for older foundation
 see steps below
 evidence of prior excavation and damp-proofing at northeast foundation

** Steps recommended in order to minimize basement leakage

1. gutters, downspouts, grading, driveways: ongoing maintenance and repair/see Exterior
2. cracks/form ties on foundation: monitor/repair as required
3. excavation/damp-proofing: monitor basement, consider step 3 as a last resort
