HOME INSPECTION REPORT

1 Kencliff Cres
Scarborough

Prepared by: Bob Papadopoulos P.Eng., RHI *

Inspection Date: May 8 2025

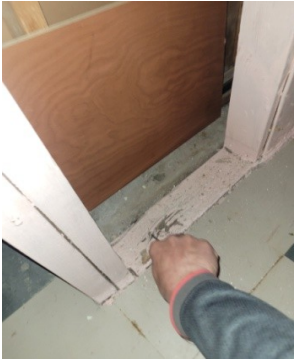
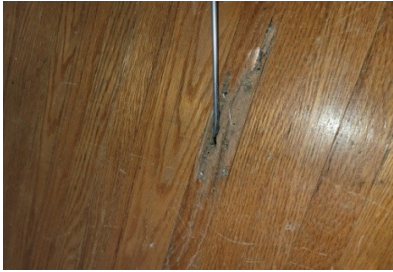
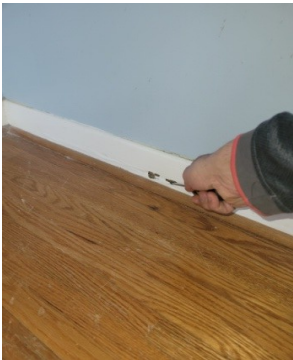
Overall well built house. The house has been treated for termites - see details.

REFERENCE LINK		http://redbrickinspections.ca/docs/4_Structure_Reference_Guide.pdf		
1 Kencliff Cres		STRUCTURE		May 8 2025
Description				
Configuration: Basement:	Foundations: Masonry Block	Floor : Wood Joists	Walls : Masonry Wood Frame (Siding)	Roof/Ceiling Framing: No Access
Limitations				
Restricted Access to: Wall Space Roof Space	Foundation Wall Not Visible: <u>95</u> % Roof Space Inspected From Access Hatch upper			
Observations/Recommendations				
<p>overall well built house</p> <p>Termites: refer to termite inspection provided by home owner evidence of past termite treatment, contact specialist for ongoing monitoring, re-treatment might be required in future</p> <p>Termite Damage: some noted in basement under steps on sill plate and in north central bedroom floors and baseboards, appears older but recommend further evaluation by specialist</p> <div style="display: flex; justify-content: space-around;">
